Intel[®] Pentium[®] III Processor Specification Update

Release Date: May 2003

Document Number: 244453-048

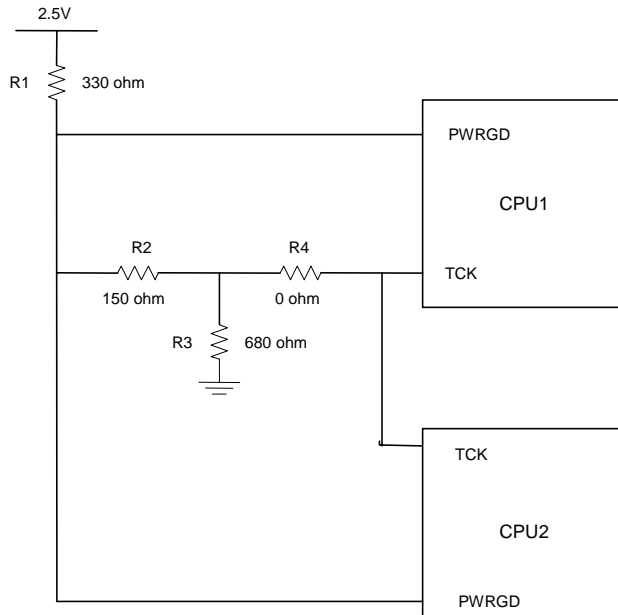
Pentium® III Processor with 512KB L2 Cache Platforms Workaround

In addition, the example workaround circuits shown do not support production baseboard test methodologies that require the use of the processor JTAG/TAP port. Alternative workaround solutions must be found if such test capability is required.

Assumes the inputs to the CPU_PWRGD are open collector signals that are Wire-ANDed together

- The example workaround circuit assumes that the PWRGD inputs into the processors are open collector. Tying the PWRGD inputs together in a Wired-AND fashion allows each processor to receive PWRGD at the same time but at the latter of the 2 separate PWRGD assertions. If separation of the PWRGD inputs to each processor is required, extra circuitry will be required.
